# Contractor's Plant & Machinery Survey Report

| Report No. and Date | SR/2026/03/442 dated 25 March 2026 |
| Name of the Insured | Vertex Infra Private Limited |

We submit this report to Sunrise General Insurance Co. Ltd. in respect of Claim No. 45230744819590000012 under Policy No. 45230744819500000067 issued in the name of Vertex Infra Private Limited, operative from 3 August 2025 to 2 August 2026, the risk location being All India, in connection with the loss dated 6 November 2025 involving the insured 21-ton class hydraulic excavator bearing machine serial number N742885.

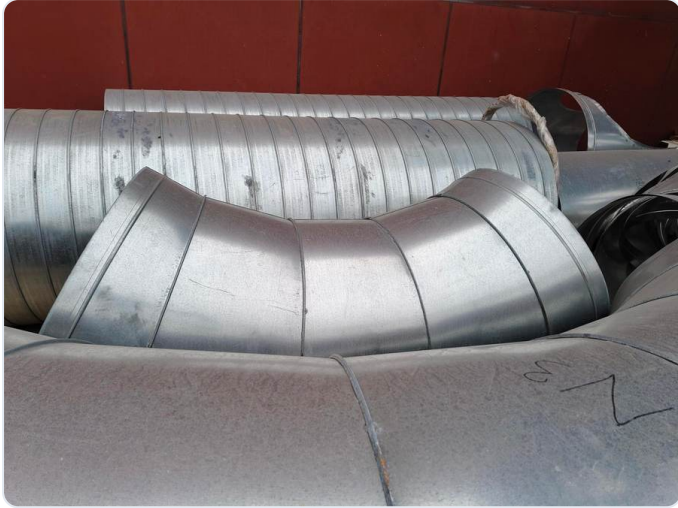
Photo 1: Site photograph, stored fabricated sections | Captured on site, geotagged

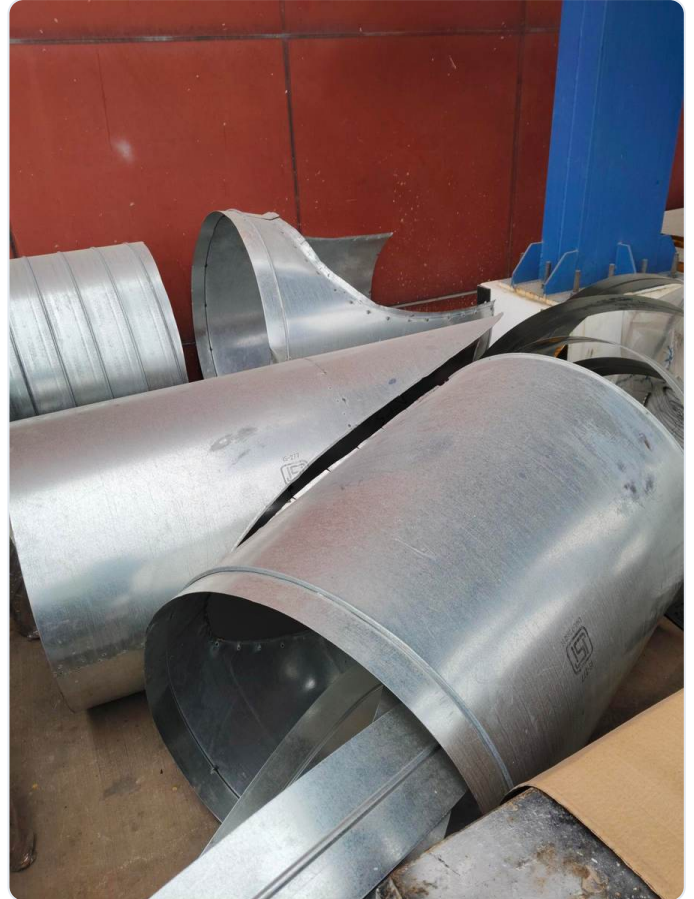
Photo 2: Site photograph, staged sections in marked lanes | Captured on site, geotagged
